# Stray Voltage on Low Standoff Components

The Doctor diagnoses an acute weak organic acid problem.

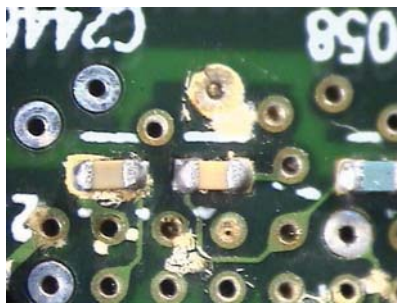
The assemblies overall showed low amounts of ionic and organic residues, with the exception of the area around the selective solder area. As seen in this photo (Figure 1), the white residue is next to the selective solder area. The white residue is a reaction with moisture after exposure to the extraction solution. The WOA (weak organic acid) levels are above 200  $\mu\text{mg}/\text{in}^2$  and are only that high in the surrounding

area of the selective solder location. The area that is contacted with the wave is low in WOA (levels of 39 to 47  $\mu\text{mg}/\text{in}^2$ ) and appears to have no problem with stray voltage based on your schematic details. But the area 1" to 2" from the opening is high in WOA flux residues. This indicates that the flux is wicking up into this critical area of the pallet and then is shielded from the thermal activation energy of the preheats and wave solder itself. This is a very correctable problem. Optimize the flux application, ensure the boards are seated completely and if flux is still present then apply a small amount of secondary heat to the area of the problem. With this additional heat the flux will be completely complexed and then become the benign residue it is everywhere else on the assembly.

**FIGURE 1:** White residue caused by a reaction with moisture after exposure to extraction solution.

Two weeks after implementing the recommended corrective actions, the ESS-biased humidity test samples passed and the process received qualification using SIR and ESS testing on functional hardware. ■
